Gunite Brake Drums

Maintenance and Installation Manual

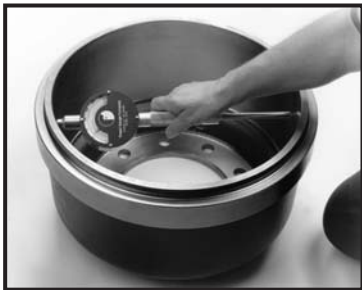
When checking brake drum diameter for wear, the diameter should not exceed 0.120" over the original diameter. When reboring brake drums, the finished diameter should not exceed 0.080" over the original diameter.

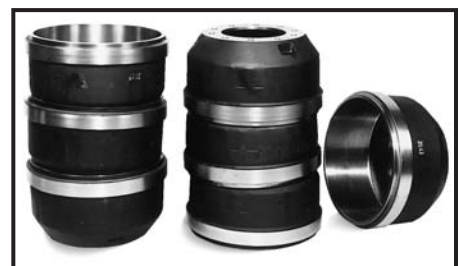
Storing brake drums by “nesting” one drum in another without a designed stacking feature or resting the drums on their side “book end”, as shown in Figure 2, will result in damage to the drums. Storing drums in any of these ways will cause an out-of-round condition to occur which will require machining to restore concentricity before installation. This will significantly reduce the service life of the drum and create unnecessary expense due to the machining of a new drum.

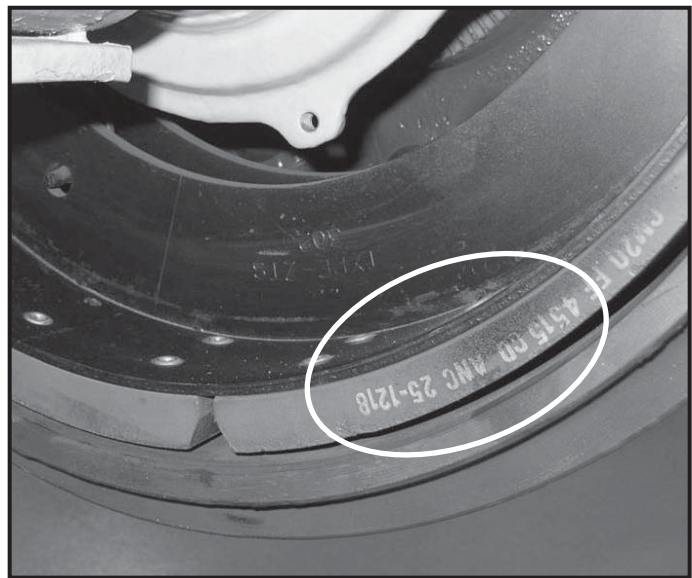
Mounting Gunite Brake Drums on "Hub Piloted" Wheel-end Assembly

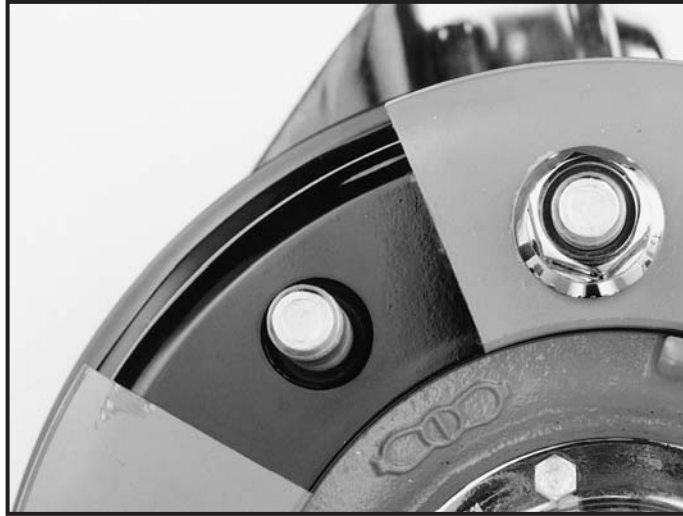
1-1/4" Bolt Hole Front Steer Axle Application
